RE: Site Inspection, Deseret Generation and Transmission, Diamond Mountain Resources Limestone Mine, M/047/066, Uintah County, Utah

Date of Inspection: October 8, 2002

M/047/066, Diamond Mountain Resources Mine, Deseret Generation and Transmission

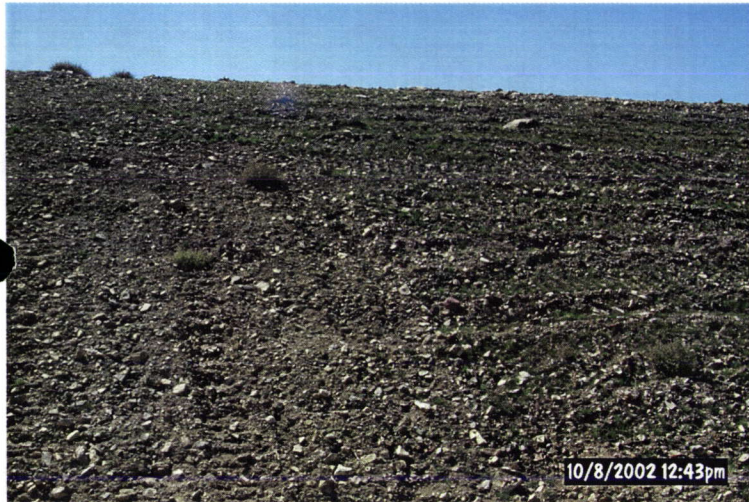
The southernmost area of the mine pit has been graded, soiled, and seeded with mixed success. The west portion of this area was ripped parallel to the contour, but the east side was apparently ripped perpendicular to the contour. In spite of the extreme drought the area has had this past spring and summer, vegetation on the west side is coming in very nicely. On the east side, however, there is almost no vegetation, either seeded species or weeds. Most of the vegetation growing on the west side consists of grasses which are hard to identify because this is their first year. Photo 1 is a view looking south at this area, so the ripped area is on the right side of the photo. There is a dramatic difference between the west and east sides which does not show up well in the photo. Photo 2 is an overall view of the reclaimed area.

**Photo 1.** Reclaimed area on the south side of the pit. Area on the right was ripped parallel to the contour and has much more vegetation than the area on the left although it is not clearly visible in this photo.

In the future, the operator should be sure to rip parallel to the contour. In the area on the south side of the pit that was reclaimed last year, it is possible some remedial work may be needed on the east side, but I recommend waiting one more season before deciding whether to do this.

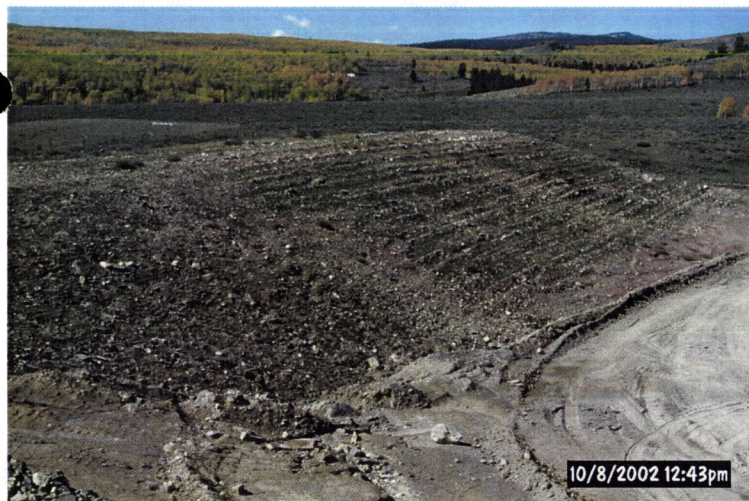
**Photo 2.** Overall view of the reclaimed area south of the pit.

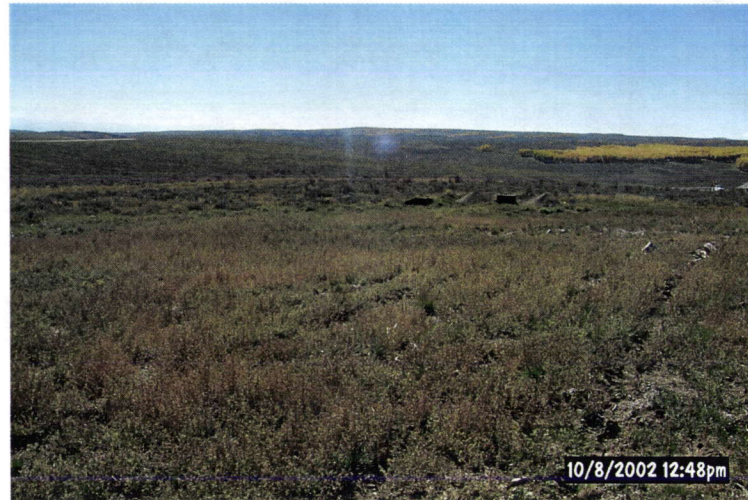
There are some areas on the northeast side of the mine that have been reclaimed. Most of these areas did not have a lot of disturbance, but the operator has scarified and, I assume, seeded them. We did not look closely at these areas to see how well the seeded vegetation was coming in, but they did have some weeds (Photo 3).

**Photo 3.** Reclaimed area on the northeast side of the mine.

The operator and the Division should continue to monitor the reclaimed areas on the northeast side of the mine.

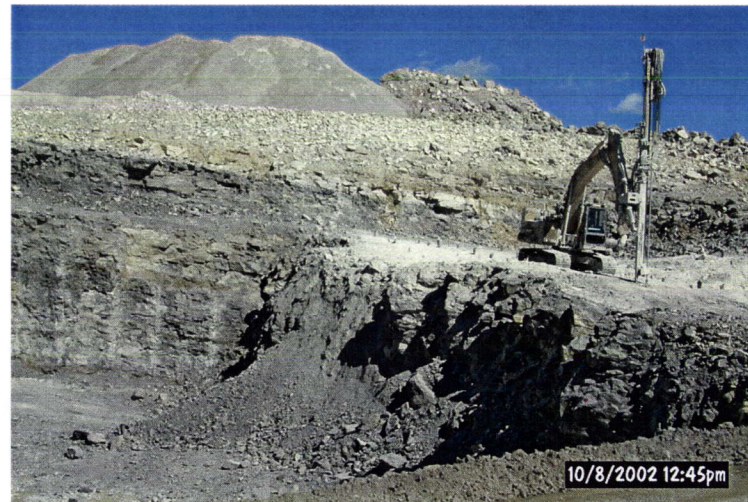
During the inspection, the operator was drilling on the north side of the pit in preparation for blasting (Photo 4).

**Photo 4.** Drilling on the north side of the pit.
